Safety information
Technical Bulletin No. 010

No. 010	Target audience Affected users	Date 2013-01-21	Number of pages 8
Affected products corpuls³	Serial numbers / Lot identification from 12600158 to 12603530 Delivery date: between 07/2012 and 12/2012	Software / Firmware -/-

with this letter we would like to inform you about the recall of the monitoring units bearing the serial numbers from **12600158 to 12603530 which have been delivered between 07/2012 and 12/2012**. This recall only applies to a limited number of **corpuls³** devices which have been delivered to the end customer in the mentioned period of time.

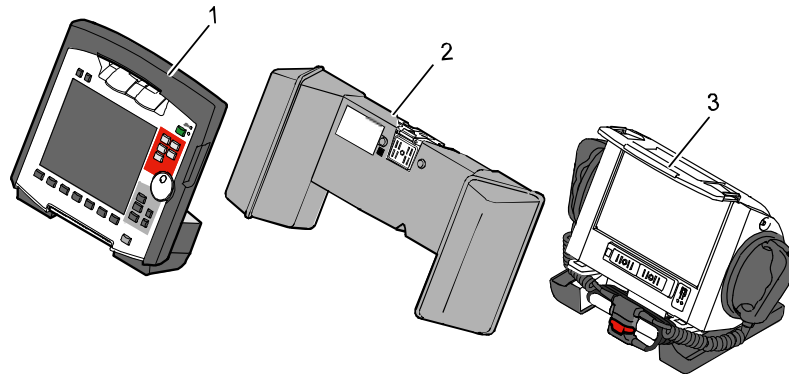
Illustration of the device combination **corpuls³**

- 1 – Monitoring Unit
- 2 – Patient box
- 3 – Defibrillator

Rating plates with position of the serial numbers
